# RO-ILS CASE STUDY 15

## BRACHYTHERAPY APPLICATOR DIGITALIZATION

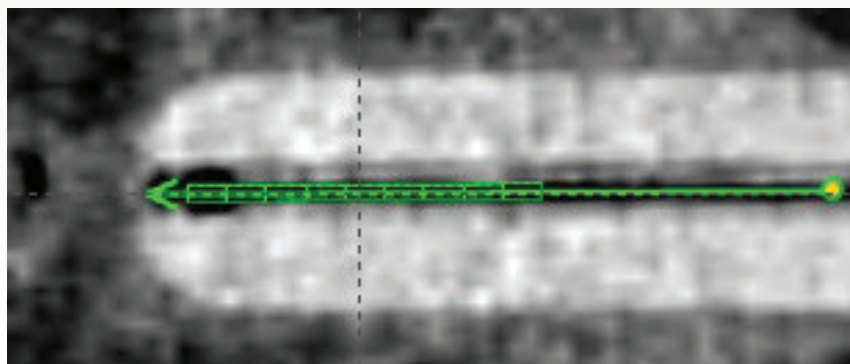
AAPM report TG-59 includes recommended training schedules for all staff, including medical physicists, involved in an HDR procedure. The process of digitizing a brachytherapy applicator is a critical step in the process and a variety of errors can occur during this step.<sup>3</sup> Correct identification of the distal and proximal ends of the catheter is imperative during the digitization process.

Figure 1: Treatment planning scan with digitization of the applicator
