RO-ILS CASE STUDY 16

PRESCRIPTION TRANSCRIPTION ERROR AND INCORRECT MUS

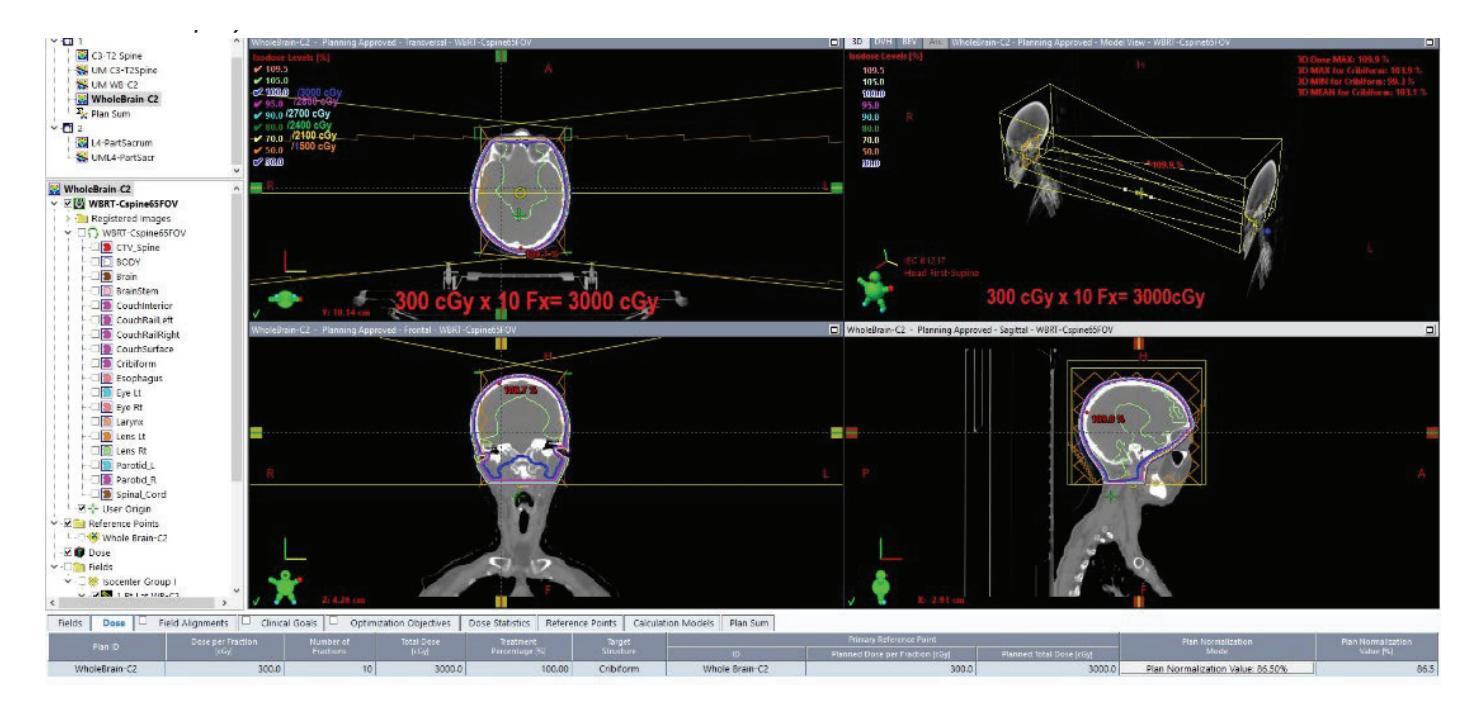
Figure 1: Idealized Version of Prescription Display

Prescribed dose is in the bottom of axial and BEV windows in the proposed 2016 white paper format. Additionally, both relative and absolute doses are keyed simultaneously in the upper left-hand corner of the axial display.

- a. Physician plan approval should be standardized; for instance, according to the CB-CHOP format¹ which stipulates a review of the prescribed dose.
- b. Review plans in absolute dose. This error would have been immediately discovered had absolute dose been reviewed. Vendors could support this by enabling easy review of plans in absolute and relative dose during plan review (Figure 1).
- c. Prescription display as part of the main isodose review window, rather than a separate tab, would be useful in assessing similar errors (Figure 1).
